Manhole Inspection Summary

Manhole # S47K2_035MH

Location Address: **1900 Ben Hill Ave. (Hydratec Inc.)** Cross Street: **Andard Ave.**

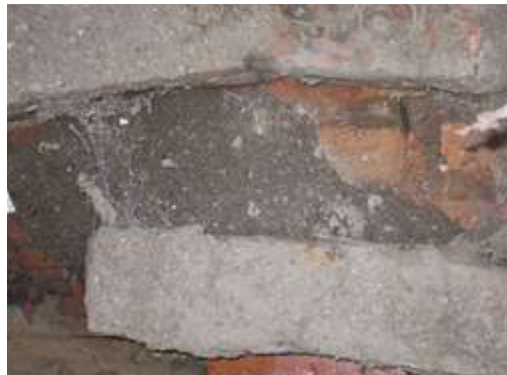
Defect 2

Slight dirt in channel

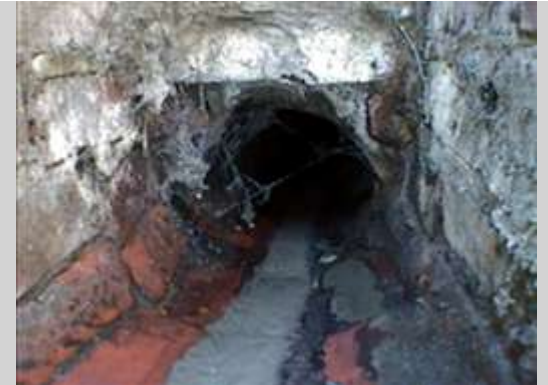
12 O'Clock Outflow

10 in. Circular Gravity Sewer
Pipe Out @ 12 O'Clock

Pipe Height: **10.8** (in.) Rod and Bar (Angled)
Pipe Material: **Clay** ☐ Pipe Lined
Invert Depth: **5.22** (ft.) Flow Characteristics: **Fast**
Deposits: ☒ None ☐ Mud ☐ Sludge ☐ Debris ☐ Grease
Silt Depth: (in.) Deposits Extent:
Infiltration: **None** Pipe Seal Cond: **Sound**

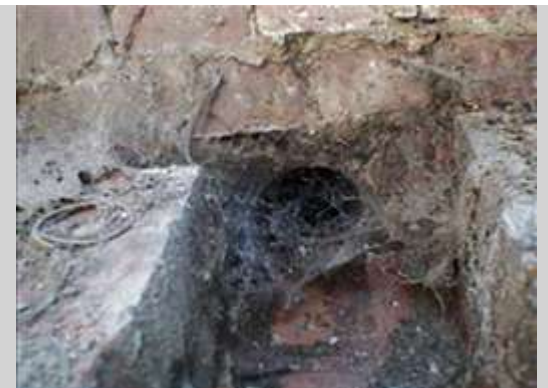
5 O'Clock Inflow

Comments **Unable to accurately measure influent pipes @ 5 and 7 O'Clock**

4 in. Circular Gravity Sewer
Pipe In @ 5 O'Clock

Pipe Height: (in.) Direct (Angled)
Pipe Material: **Unknown** ☐ Pipe Lined
Invert Depth: **2.72** (ft.) Flow Characteristics: **None**
Deposits: ☒ None ☐ Mud ☐ Sludge ☐ Debris ☐ Grease
Silt Depth: (in.) Deposits Extent:
Infiltration: **None** Pipe Seal Cond: **Sound**

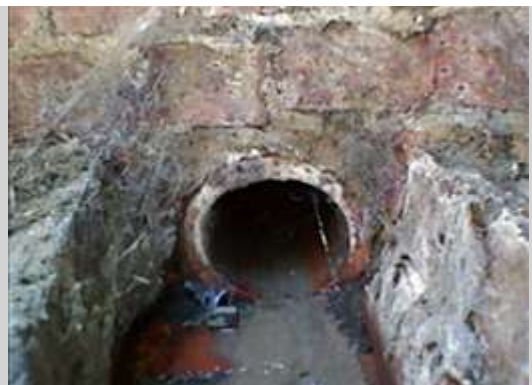
7 O'Clock Inflow

4 in. Circular Gravity Sewer

Pipe In @ 7 O'Clock

Pipe Material: **Clay** ☐ Pipe Lined

Invert Depth: **2.78** (ft.) Flow Characteristics: **Fast**
